Home Inspections

3705 Limerick Road
Myrtle Beach, SC 29588

Inspection Date: 9/6/2014

Job Number: 14-0009

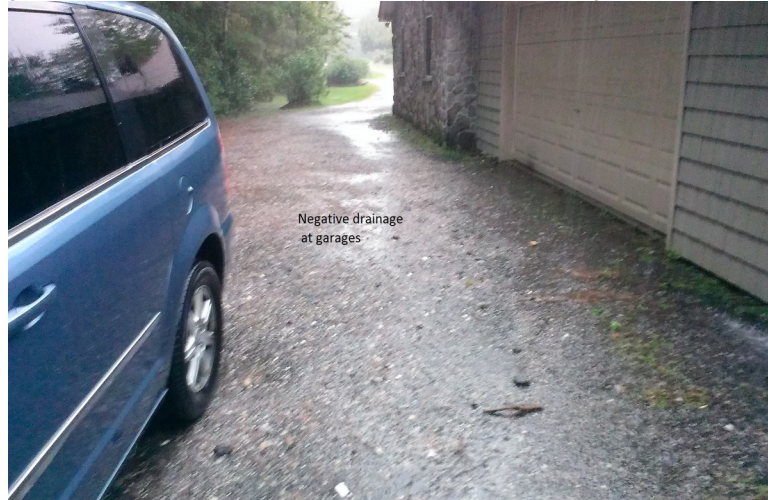
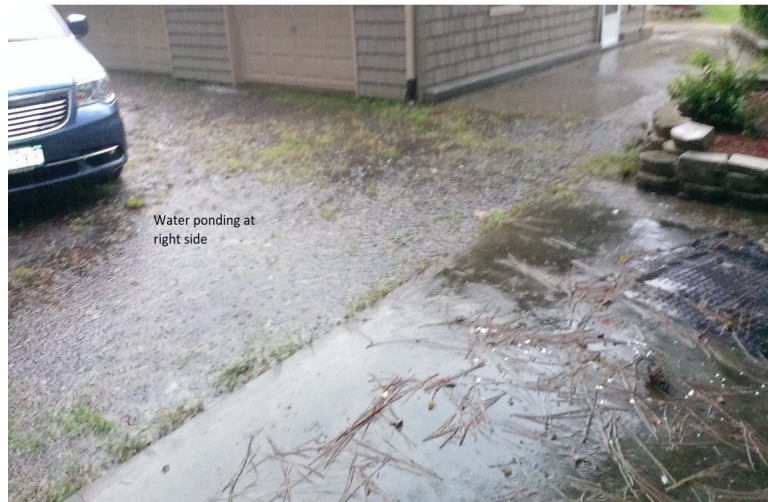
Negative drainage --- Drainage is negative, which means water shed from the roof or surrounding area will flow toward the structure. To alleviate, regrade the immediate grade at the foundation to divert water away from the building.

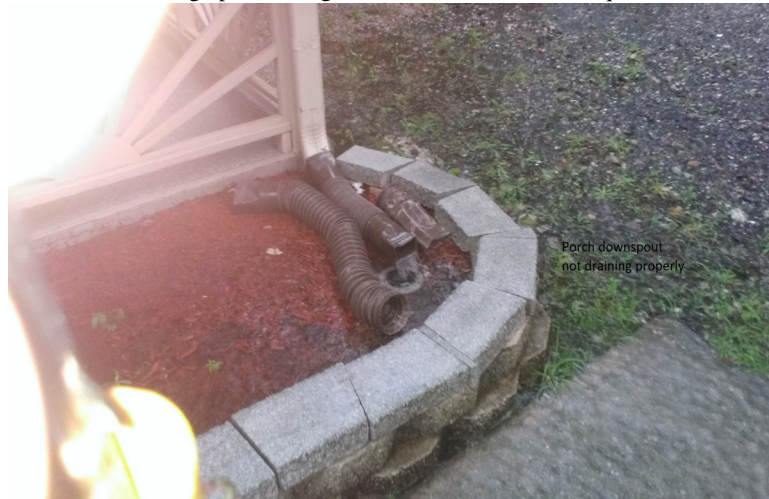
Discharge underground --- Downspouts are discharging into a below grade drainage system. The drainage system is inaccessible and therefore not inspected. Also the drain as shown is backing up indicating it is either blocked or inadequate.

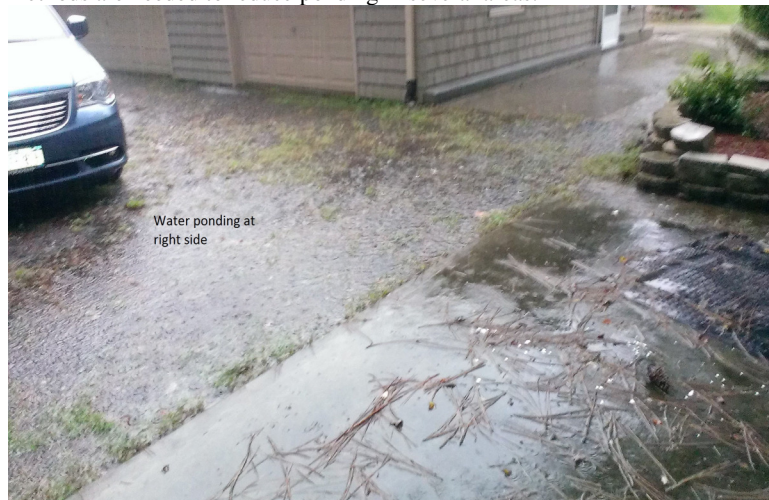
Standing water --- Standing water was present. This condition could cause water penetration in the structure and produce mold or rot. Additional water control methods are needed to reduce ponding in several areas.

Defective

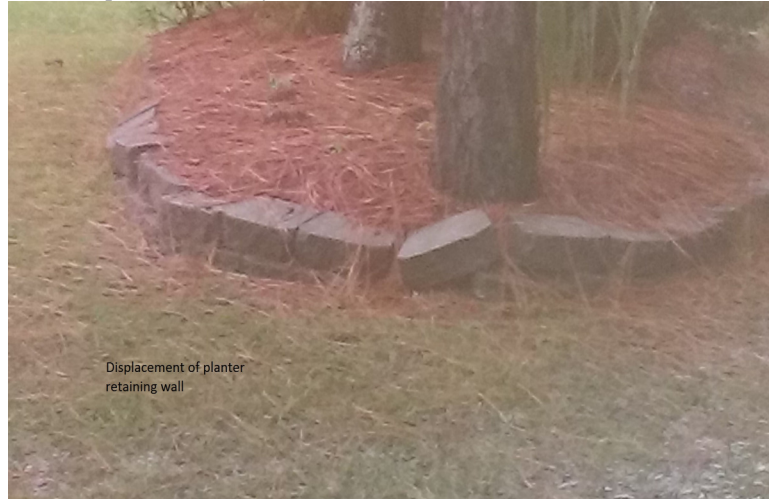
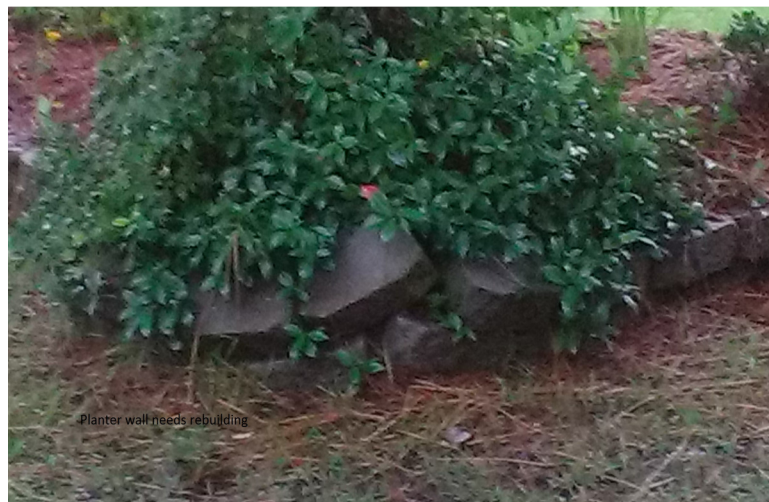
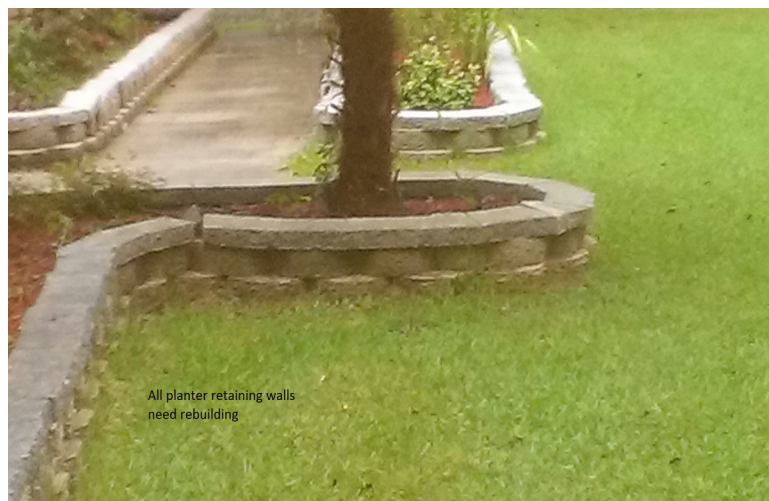
Location: planters around yard

Displacement --- Displacement was observed. This is do to erratic movement from its original position. Repairs should be made as needed.

Defective

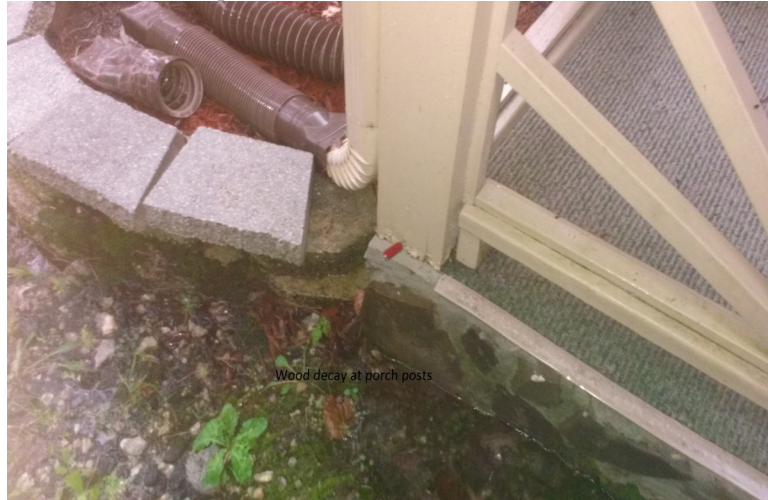
Location: three wood posts

Open
Wood decay --- Continual high moisture levels cause decomposition of wood by fungi. Decay fungi can be detrimental to building elements and moisture can also attract wood boring insects. Replace damaged wood as needed and control future moisture level.

Rating: **Defective**

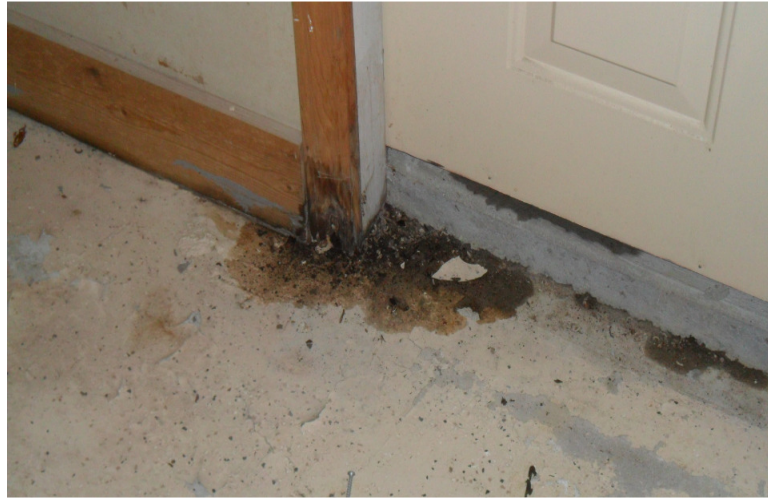
Attached Garage
Wood decay --- Continual high moisture levels cause decomposition of wood by fungi. Decay fungi can be detrimental to building elements and moisture can also attract wood boring insects. Replace damaged wood as needed and control future moisture level.
Location: rear door casing

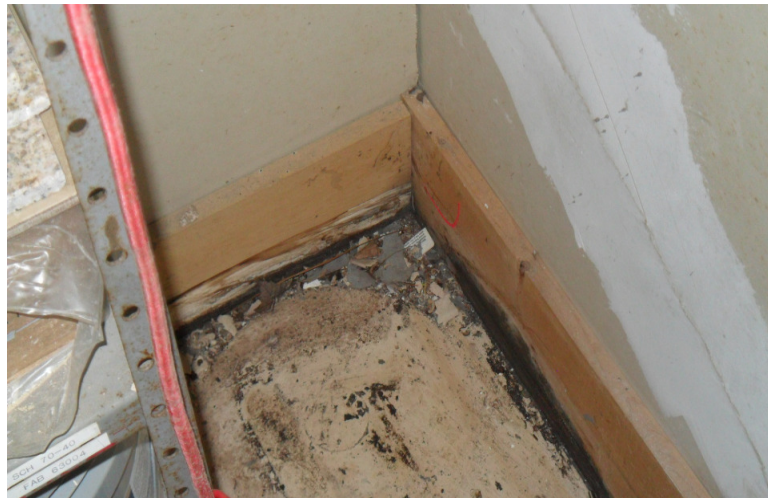
Mold/Mildew --- Molds and mildew are fungi found in damp poorly vented areas and can be detrimental to your health. Remove using an anti-mildew detergent and control future moisture level. Call a professional if mold is wide spread or it returns after cleaning.
Location: several places

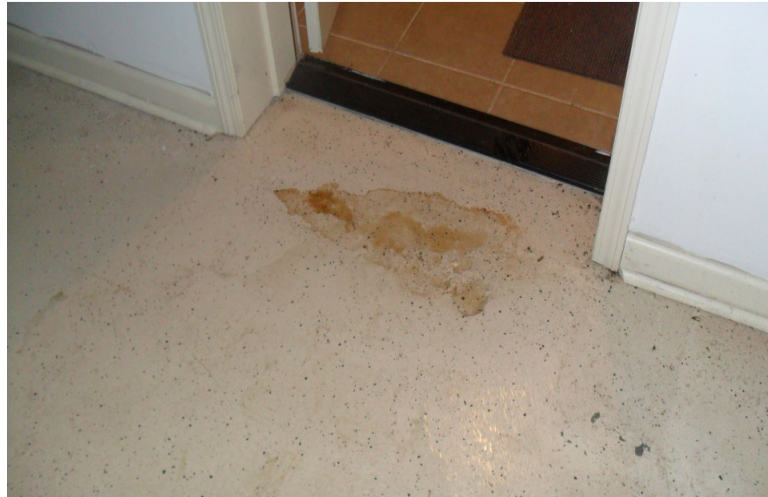
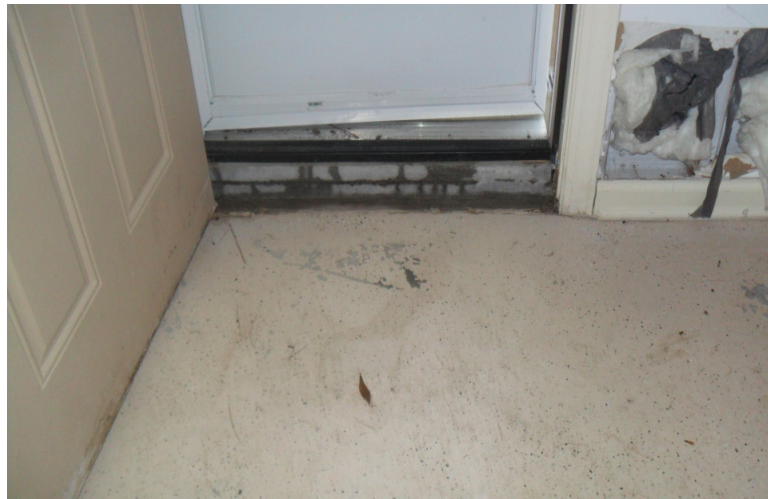
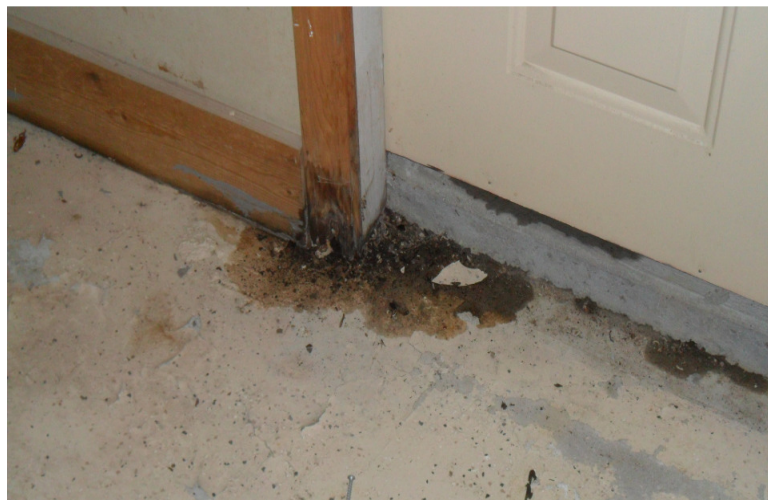
Active water --- Active water penetrations were noted at the time of the inspection. Recommend the source be determined and corrected to prevent further occurrence.

Rating: [Defective](#)

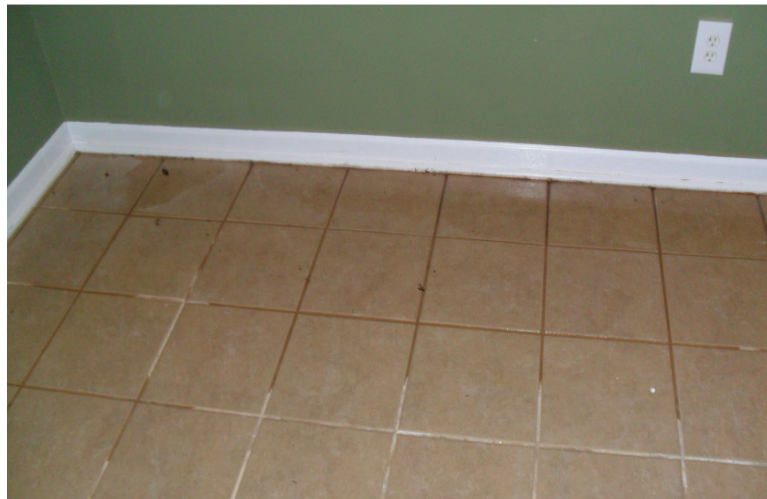
Type: Carpet, Laminate, Ceramic tile
Conditions: **Active water ---** Active water penetrations were noted at the time of the inspection. Recommend the source be determined and corrected to prevent further occurrence.
Location: family room

Comments: Step trim from hallway to living room is improper creating a trip hazard and should be re-installed properly.

Rating: [Defective](#)

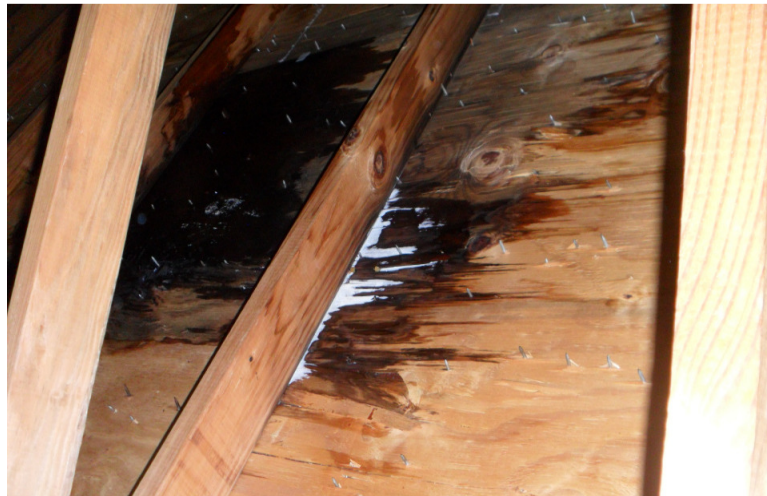
Mold/Mildew --- Molds and mildew are fungi found in damp poorly vented areas and can be detrimental to your health. Remove using an anti-mildew detergent and control future moisture level. Call a professional if mold is wide spread or it returns after cleaning.

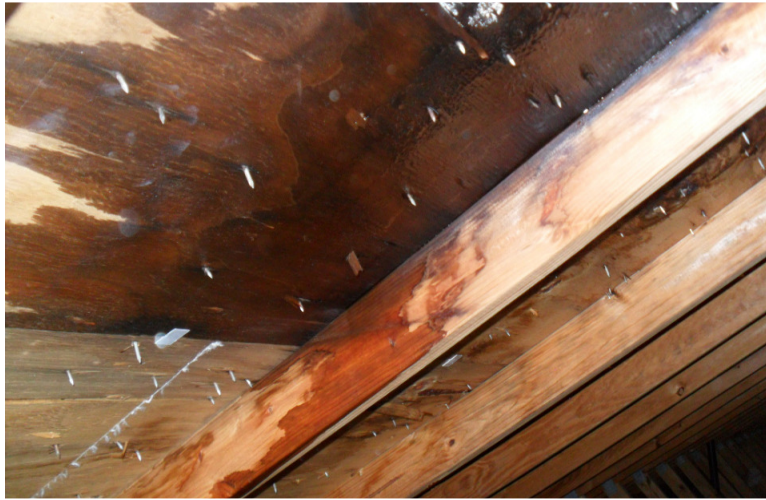
Active leak --- Active leak was noted. The source of the leak should be determined and corrected to prevent further occurrence.
Location: several places

Rating: **Defective**
